Scuola Politecnica  
***La sicurezza in ambito industriale ed ambientale***  
*Palermo, 2 dicembre 2014*

# **LA SICUREZZA NELL'INDUSTRIA DI PROCESSO: LEZIONI DAGLI INCIDENTI**

**PROF. FRANCO GRISAFI**

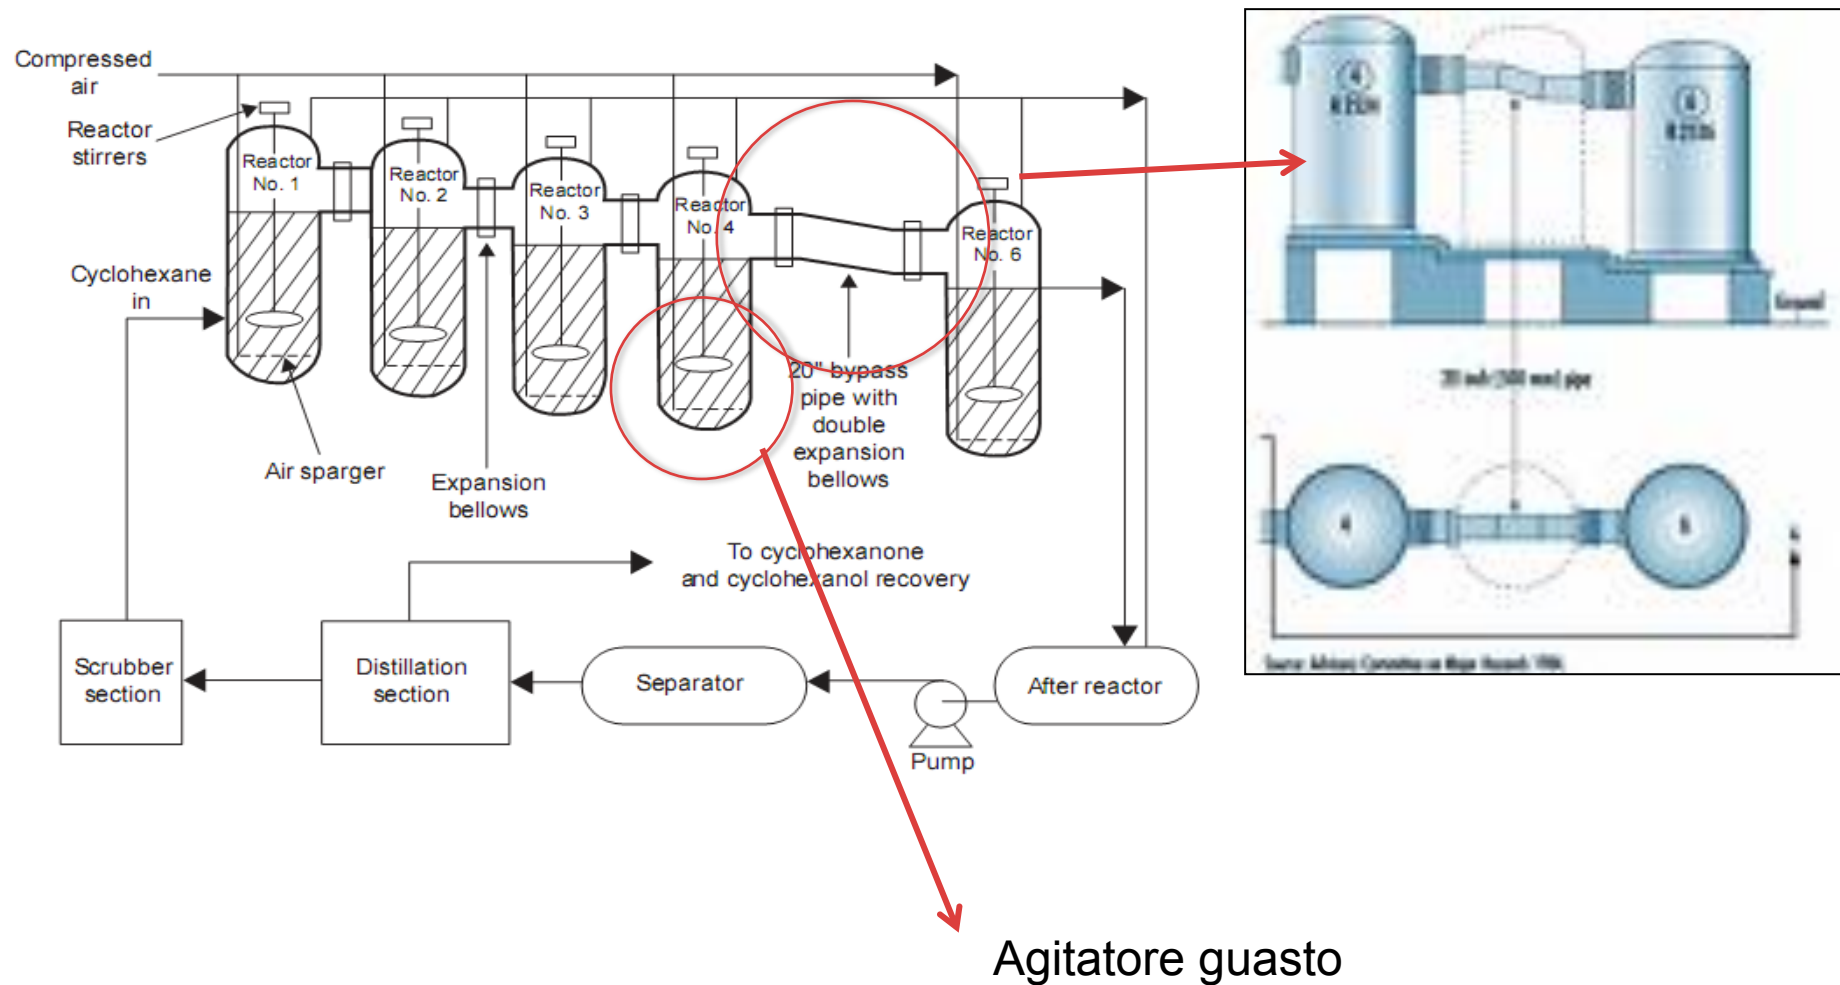
## SIMPLIFIED FLOW DIAGRAM OF CYCLOHEXANE OXIDATION PLANT AFTER MARCH 1974 (WHITTINGHAM, 2005)

1. A causa di una perdita al reattore 5 va fuori uso.
2. Per non fermare la produzione si decide di bypassarlo, realizzando un collegamento temporaneo tra i reattori 4 e 6.
3. Le connessioni originali erano fatte con tubazioni da 28", l'installazione del bypass viene fatta con un tubo da 20" (mancavano quelli da 28"... ) ed eseguita da personale non specializzato
4. Nessun ingegnere meccanico ha supervisionato il lavoro
5. Viene effettuato un test di tenuta con aria compressa, ma nessuna prova idraulica di resistenza alla pressione sulla nuova connessione.

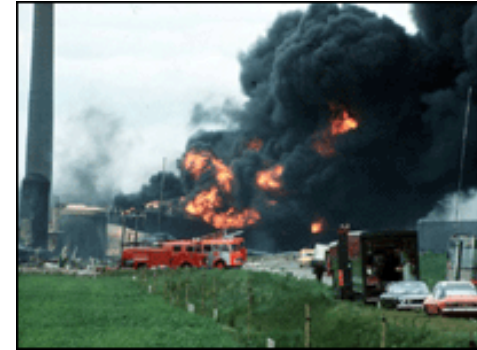
## SEQUENZA DEGLI EVENTI: L'INCIDENTE

9. Ore 16:53 del 1 giugno 1974: si verifica una massiccia esplosione con una potenza stimata (a posteriori) equivalente a 15-45 tonnellate di TNT.
10. Il rumore dell'esplosione viene percepito a più di 40 km dall'impianto e causa danni catastrofici nel raggio di 8 km.
11. 28 operai restano uccisi: 18 nella sala controllo, 9 nel resto dell'impianto e un autotrasportatore colpito da infarto. I morti sarebbero stati centinaia se l'incidente non fosse avvenuto il sabato.
12. nelle successive indagini la tubazione di 20" viene ritrovata danneggiata, ma non dall'esplosione!

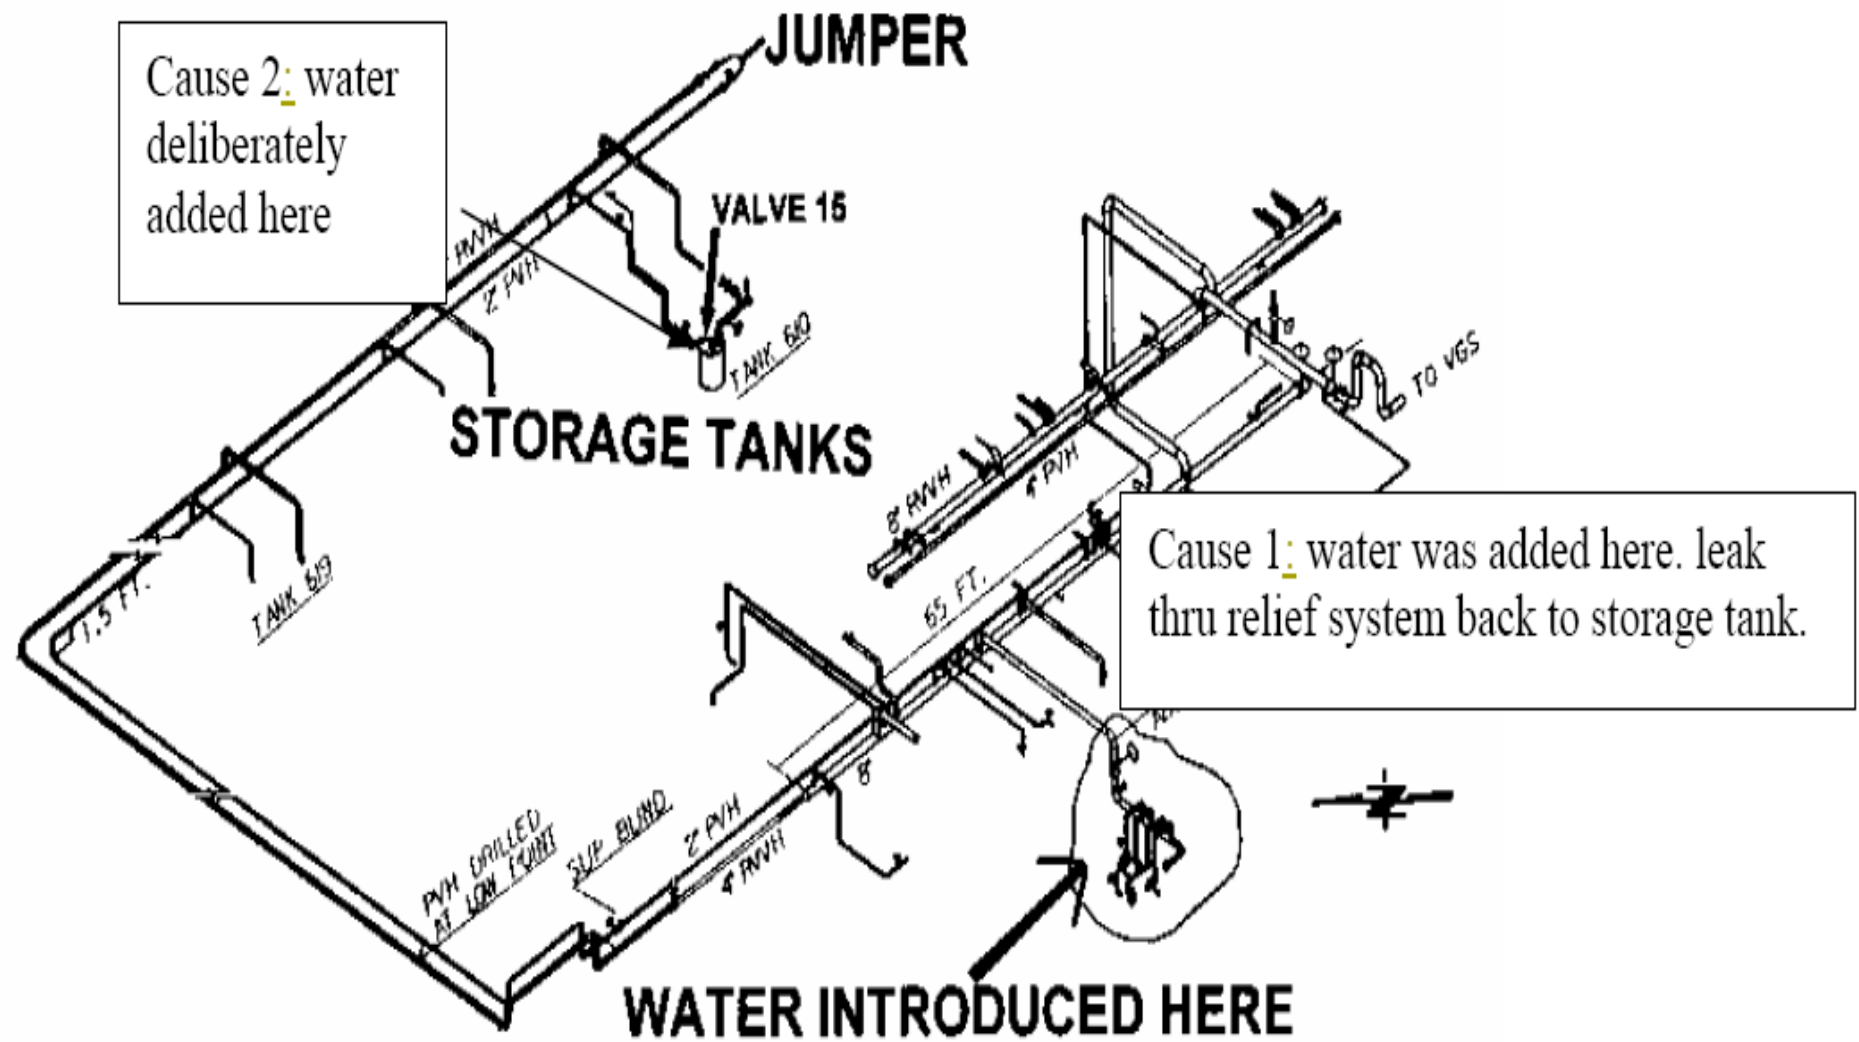
The water and MIC reaction initiated the formation of carbon dioxide which, together with MIC vapours, was carried through the header system and out of the stack of the vent gas scrubber by about 11:30 to 11:45 p.m

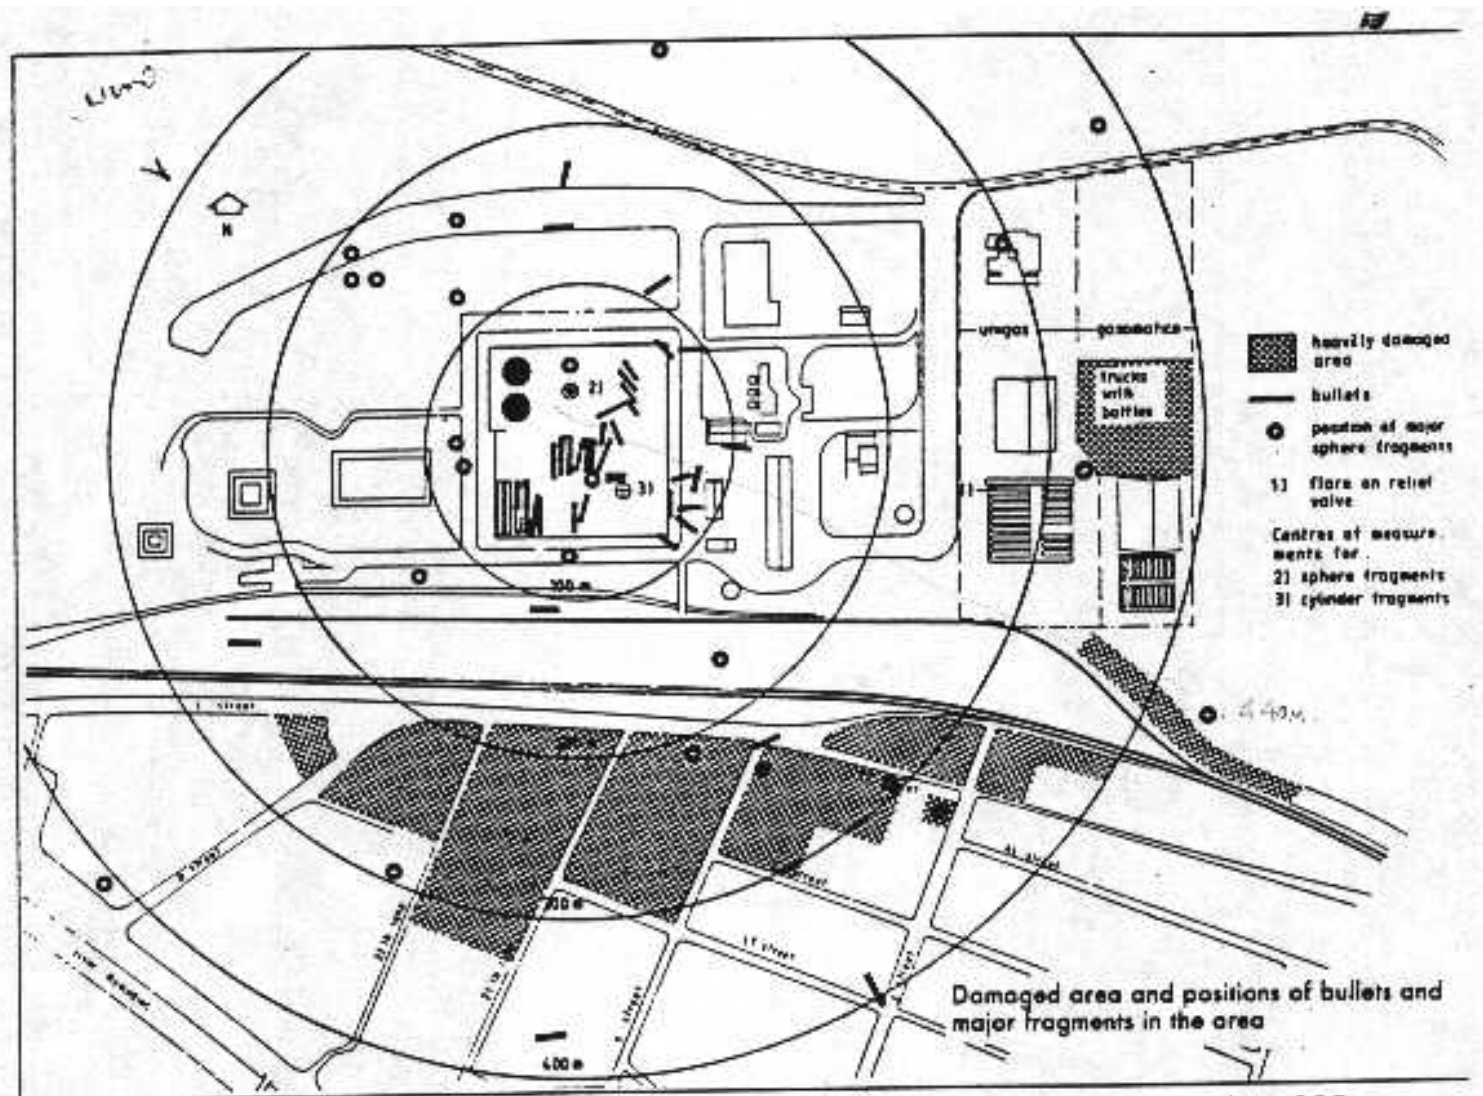
# PLOT PLAN - AFTER

Sketch of the damaged area. Some major sphere fragments were propelled more than 800 m. Note the damage to trucks with gas-filled bottles at the neighboring Gasomatico plant. Source: TNC

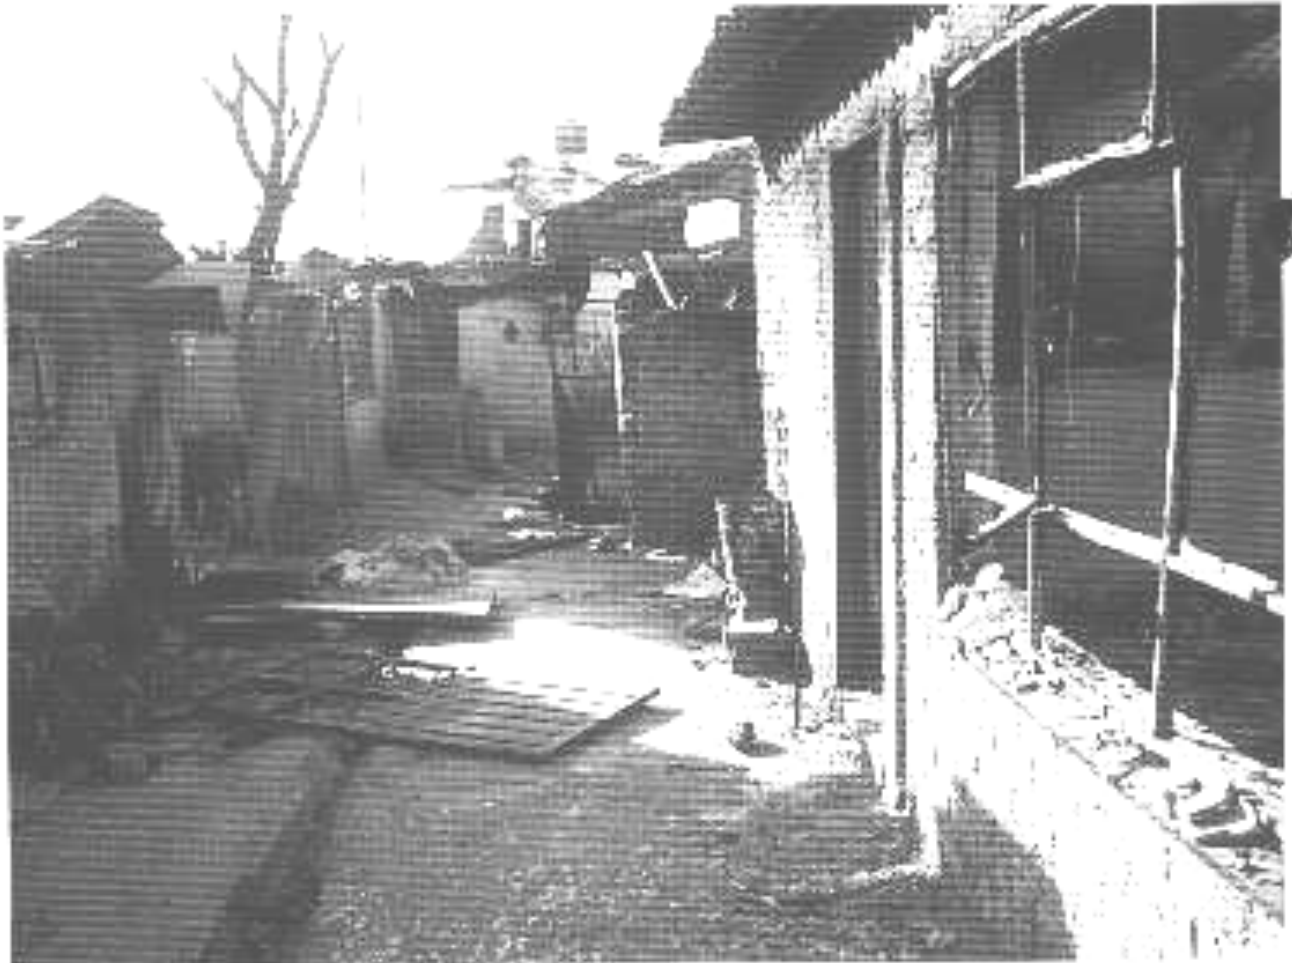
# NEARBY HOUSES

The desolation of the burnt-out houses recalled a war scene.

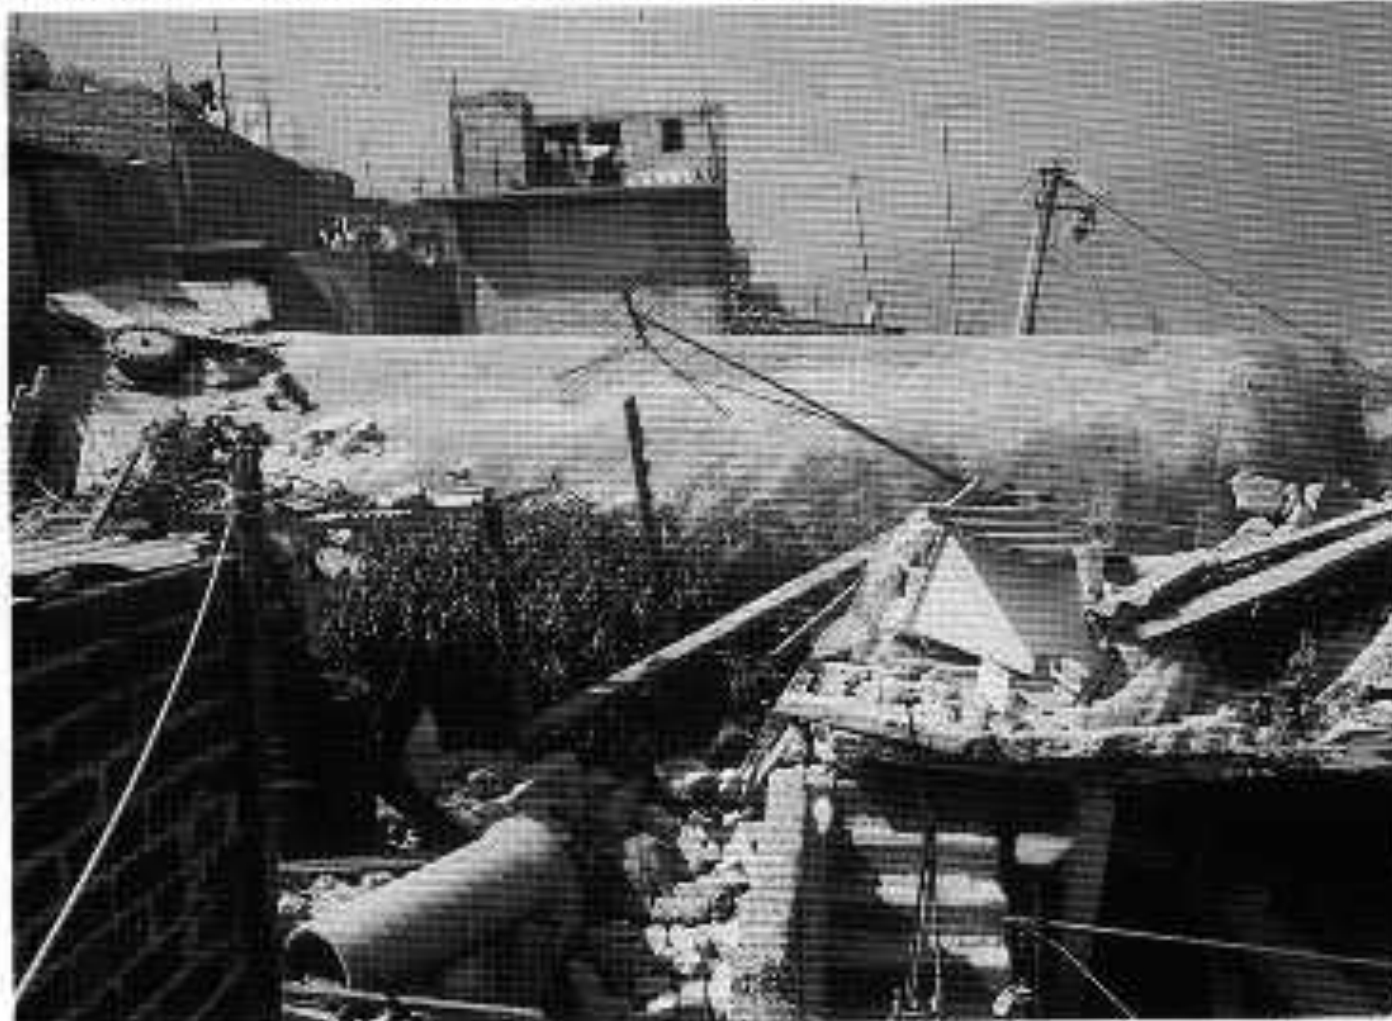
# MAXIMUM MISSILE

The cylindrical tank that flew furthest penetrated some 1,200 m into the housing area and crashed into a 2 storey house vacated one hour before.
