Scuola Politecnica  
***La sicurezza in ambito industriale ed ambientale***  
*Palermo, 2 dicembre 2014*

# **LA SICUREZZA NELL'INDUSTRIA DI PROCESSO: LEZIONI DAGLI INCIDENTI**

**PROF. FRANCO GRISAFI**

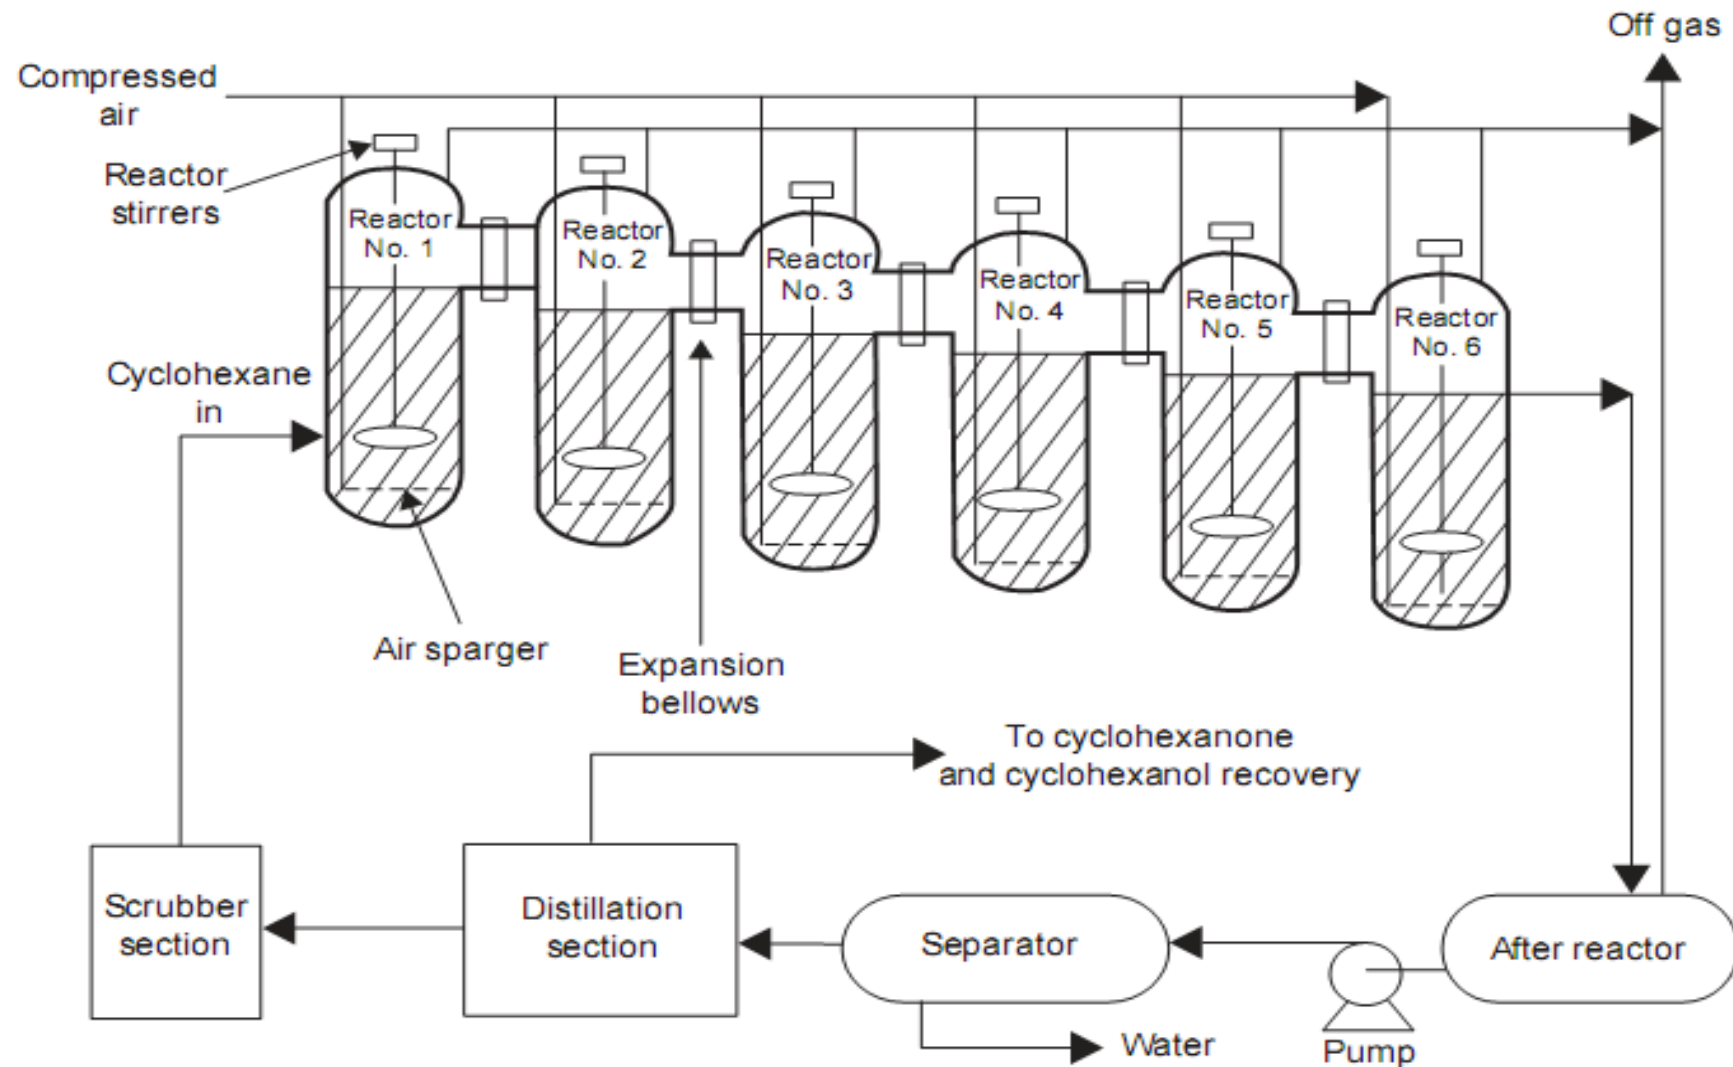
## SIMPLIFIED FLOW DIAGRAM OF CYCLOHEXANE OXIDATION PLANT BEFORE MARCH 1974 (WHITTINGHAM, 2005)

1. A causa di una perdita al reattore 5 va fuori uso.
2. Per non fermare la produzione si decide di bypassarlo, realizzando un collegamento temporaneo tra i reattori 4 e 6.
3. Le connessioni originali erano fatte con tubazioni da 28", l'installazione del bypass viene fatta con un tubo da 20" (mancavano quelli da 28"... ) ed eseguita da personale non specializzato
4. Nessun ingegnere meccanico ha supervisionato il lavoro
5. Viene effettuato un test di tenuta con aria compressa, ma nessuna prova idraulica di resistenza alla pressione sulla nuova connessione.

- Le conclusioni degli esperti sulle cause dell'incidente attribuiscono alla rottura del bypass da 20" la responsabilità principale della fuga di gas e della successiva esplosione.
- Vengono formulate due ipotesi sulla rottura, basate sul non adeguato dimensionamento del bypas, ma nessuna di esse è completamente soddisfacente. (il bypass ha funzionato correttamente per due mesi, prima di collassare ...).

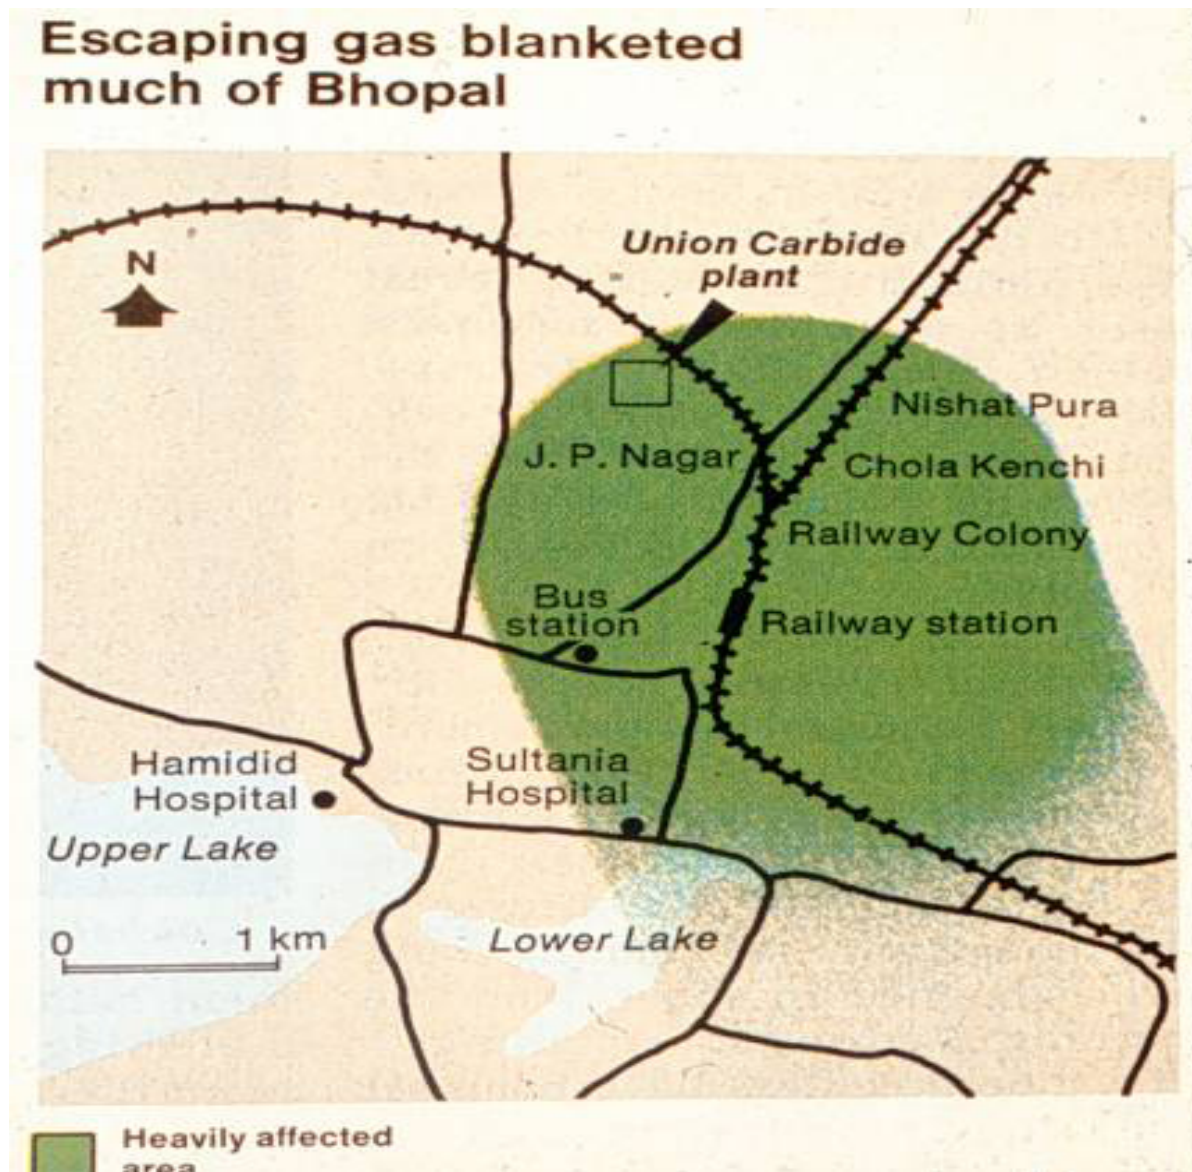
# THE AFFECTED AREA

It is presumed that between 20 and 30 tonnes of MIC were released during the hour that the leak took place.

The gas leaked from a 30 m high chimney and this height was not enough to reduce the effects of the discharge.

The high moisture content (aerosol) in the discharge when evaporating, gave rise to a heavy gas which rapidly sank to the ground.

The weak wind and the weak vertical turbulence caused a slow dilution of gas and thus allowed the poisonous gas to spread over considerable distances.

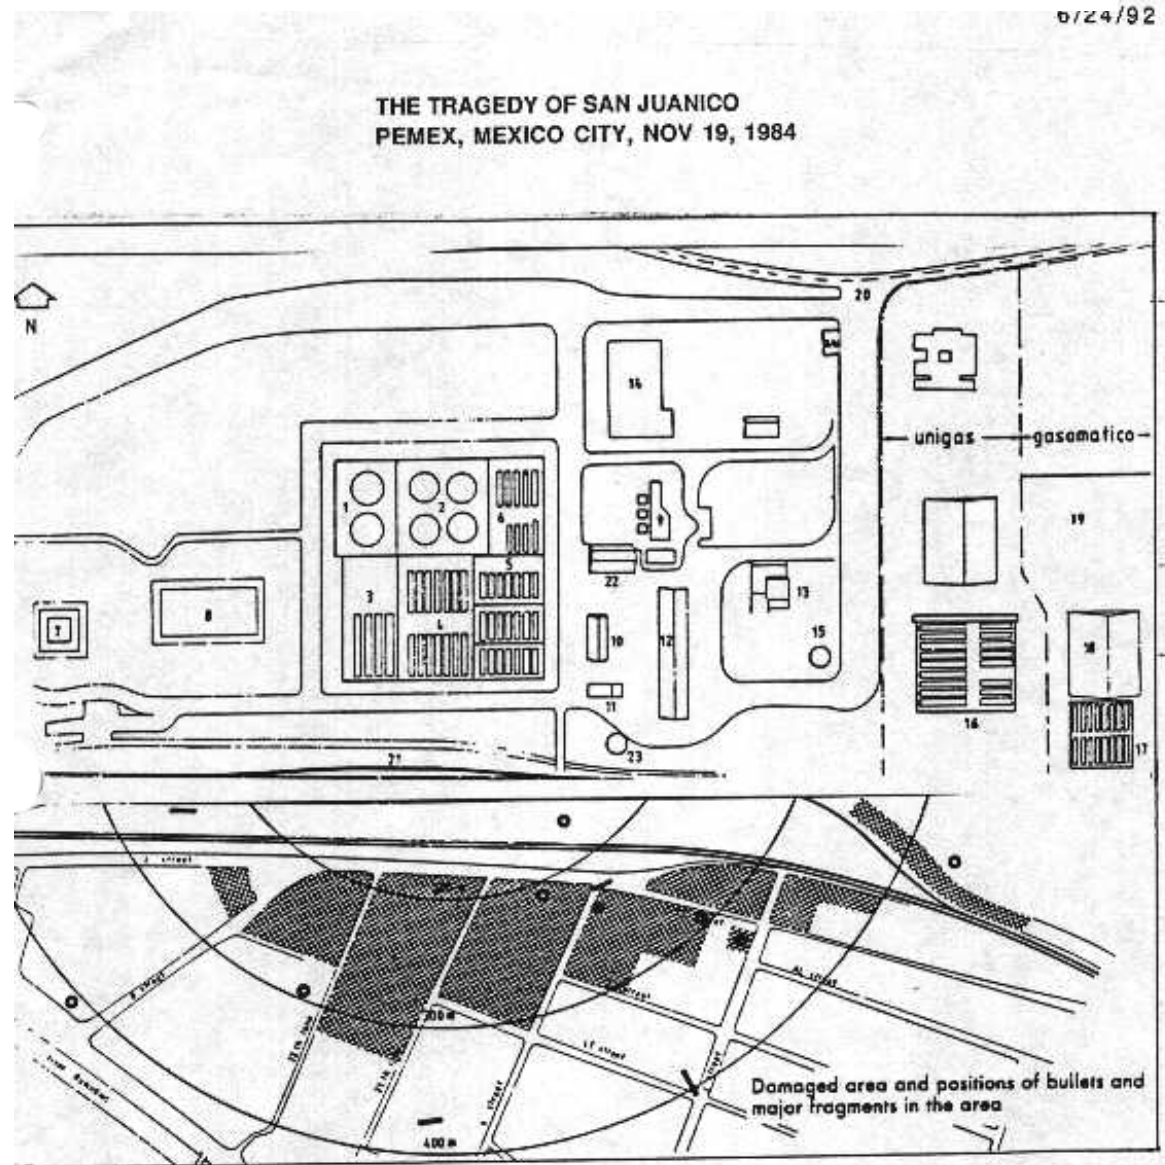
# PEMEX PLOT PLAN - BEFORE

Plant was 25 years old and built to 1950 API standards of the U.S.
